Measurement of Riverbank Erosion Rates of Pusu River Using Erosion Pins Method

Nur Aqilah Mohd Rosli¹, Saerahany Legori Ibrahim^{1*}, Rabitah Handan², Md Noor Salleh¹

DOI: <https://doi.org/10.30880/ijie.2021.13.03.017>

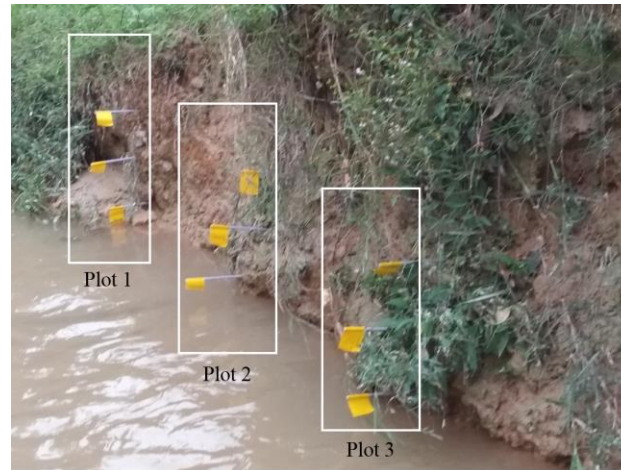
Fig. 2 - Erosion pins installed at plot 1 until plot 3 of site B

Fig. 2 shows the erosion pins installed at plot 1 until plot 3 of site B. Erosion pins exposure were measured approximately four times a week and after every rainfall event. The rate for each plot was measured starting from February 2019 to April 2019. Measurements were taken from the tip of the rod to the bank surface to account for material removal. Pin resetting was done after each storm event to avoid loss of pin. Field observation were also made to identify the factors affecting the rates of bank erosion.

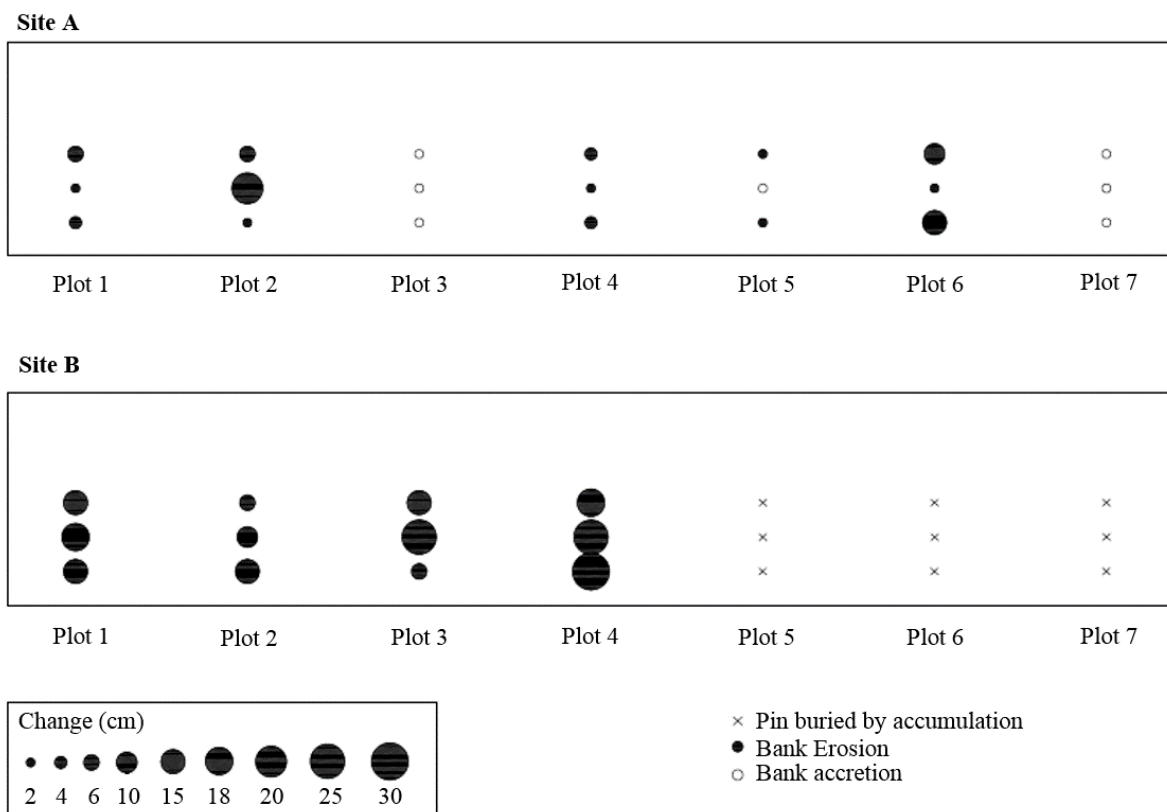
**Fig. 3 - Spatial variation of bank erosion at the end of measurement period**

The bank erosion rates with respect to each pin for both sites at the end of measurement period were represented in the spatial variation shown in Fig. 3. The bank erosion rates were illustrated by proportional circle representation of erosion pin data. The size of the circle represents the change in erosion pin length over the period of measurement. The maximum erosion at site A can be found at plot 2 and 6 with the highest pin net change value of 15.70 and 20.70 cm. Plot 3, 5 and 7 of site A were experiencing deposition and it was observed that there is also an increase in the density of vegetation at these plots. Although it was hard to identify the exact cause of aggradation at these plots, there are some possible causes which include deposition of sediment during high flows, soil expansion, as well as parallax error when the readings were taken. Based on field observation, after every heavy rainfall event, bank sections without riparian vegetation will undergo net erosion while bank section with riparian vegetation will undergo net deposition. The vegetation may have trapped the coarse sediments that are deposited at the bank during high flow. Site B was found to be experiencing more erosion compared to site A. Plot 3 and 4 at site B recorded the highest pin net change value of

27.30 and 30.20 cm. Bank failure was also found at site B after 47 days since installation of pins where 9 out of 21 pins at the site were buried by accumulation. Site B which is situated on the outside bend undergone massive erosion as the results of high flow velocity directed to the bank. Due to high amount of soil deposited at the site after heavy rainfall event, there is a significant difference in the depth of the river over the period of measurement.

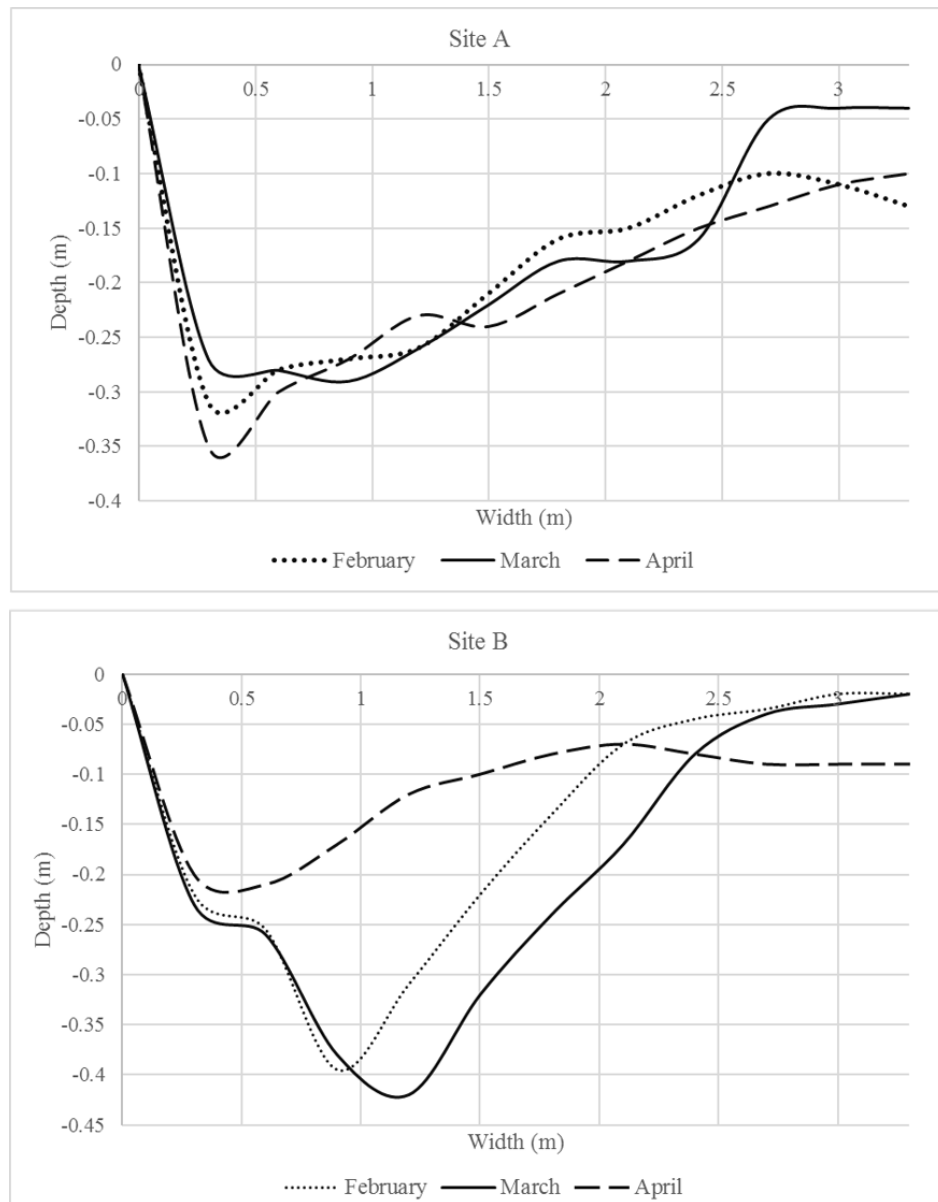
Fig. 4 - Cross section profile of site A and site B from February 2019 to April 2019

Fig. 4 shows the cross-section profile measured at site A and site B over the three month of measurement period. Subtle changes in channel depth can be seen at site A over the three months where the depth increases from February until April. Based on field observation, the depth of river increases after heavy rainfall event due to basal erosion. The right side of the channel is shallower as deposition of sediment occurs here while erosion occurs at the left side of the channel. There was a small change in depth between month of February and March at site B. However, an abrupt change in depth can be seen in the month of April after heavy rainfall event. Huge amount of sediment was deposited at the site after the heavy flow, causing the depth of river to decrease significantly. The pattern of the cross-section profile for all three months were the same where the outside of the bend was considerably deeper compares to the inside of the bend where decomposition of sediments occurs. However, the trend of site A and site B were contradicted where the channel depth at site A increases over the period of measurements while the channel depth at site B decreases. This was mainly due to the series of heavy storm events that occurred at the end of March 2019 until end of April 2019. Both sites recorded higher erosion rates in this period as reflected in the cross-section profile of site A where the channel depth increases due to basal erosion. On the other hand, bank failures occurred in site B causing the bank materials to enter the river and deposited at the bed.
